April 1946 as  
Memorandum Report E6C07

**TESTS OF CAST ALUMINUM-ALLOY MIXED-FLOW IMPELLERS**

By John E. Douglas and Irving R. Schwartz

## NACA AIRCRAFT ENGINE RESEARCH LABORATORY

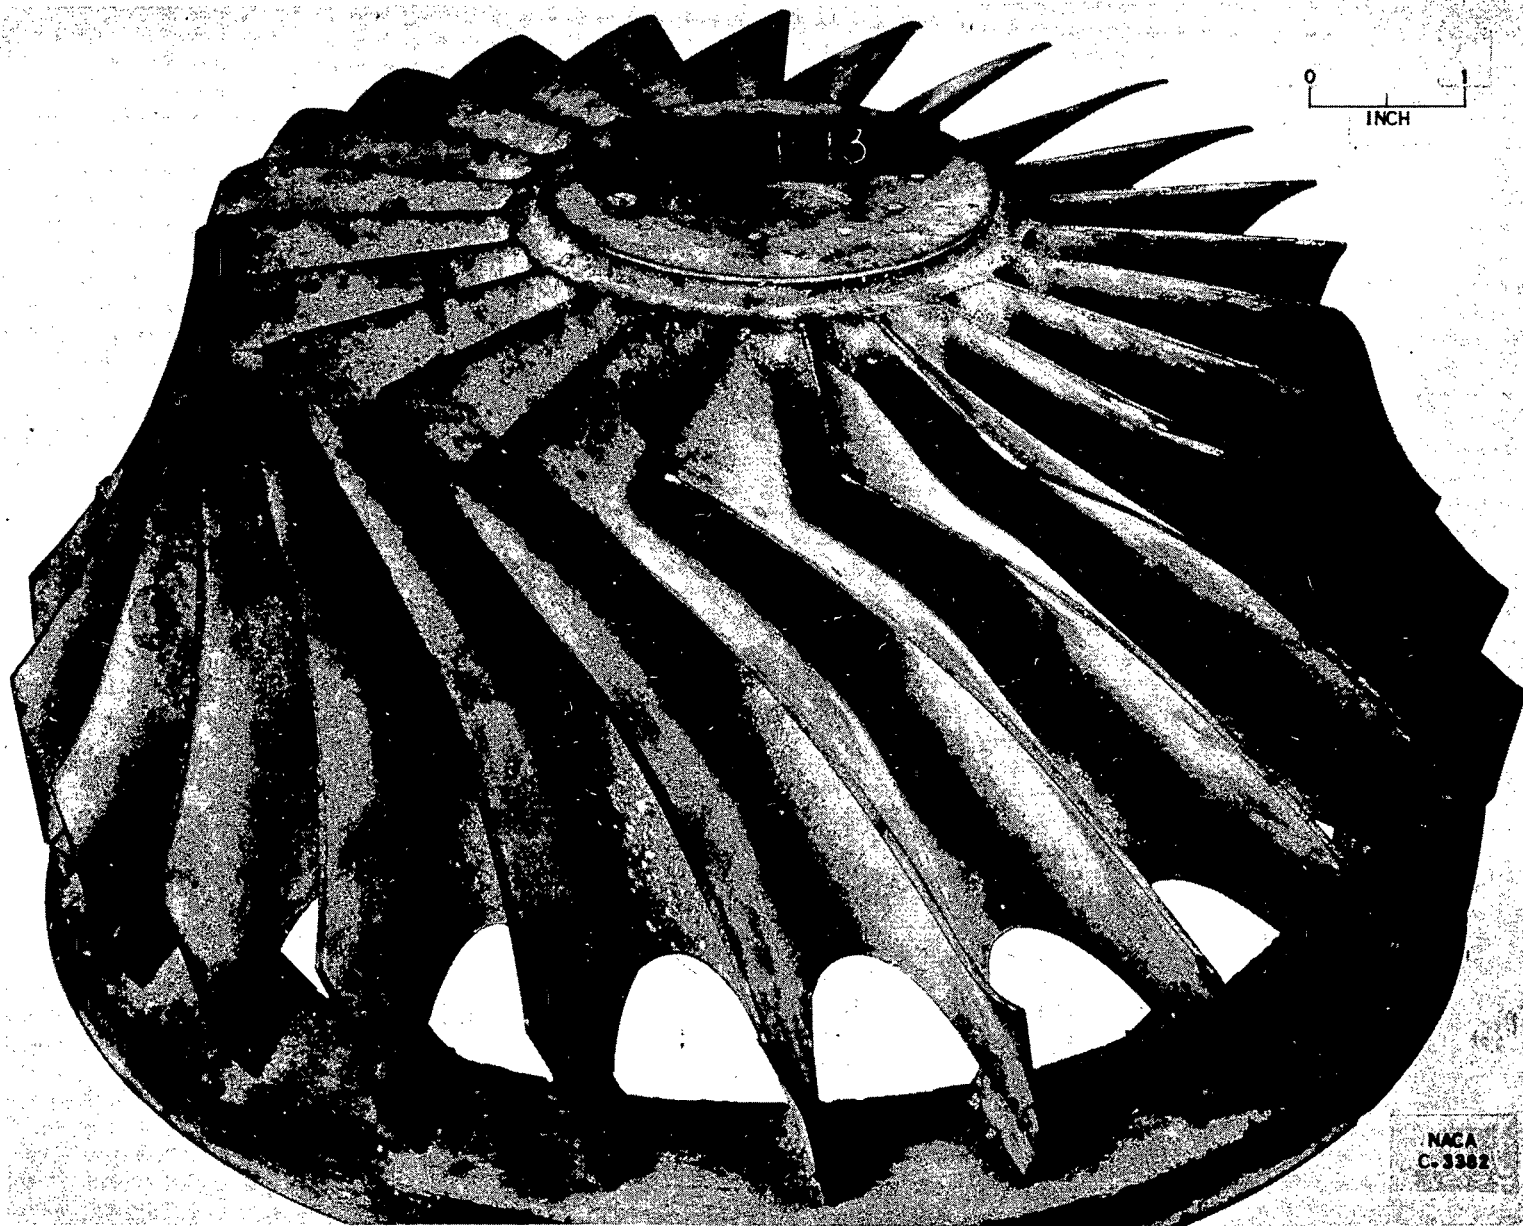
Figure 1. - Cast mixed-flow impeller received from the U.S. Naval Engineering Experiment station, Annapolis, Md.

Impellers. - Twelve mixed-flow impellers were cast by the lost wax process using a machined experimental centrifugal impeller as a master pattern. This impeller is of the mixed-flow type with 23 backward-swept blades. It was designed to discharge the air with an axial velocity component. Unlike the conventional centrifugal impeller, the blades do not have abruptly curved sections at the inlet. Because of the shape of the impeller passage, the angular acceleration of the air is continuous along a radius; the angular velocity of the air, however, is always less than that of the impeller. A typical cast impeller furnished by the U. S. Naval Engineering Experiment Station, Annapolis, Md., is shown in figure 1. The feeder flange, which was removed from the finished impeller, supports the blade tips and helps prevent warping during the heat-treating process.

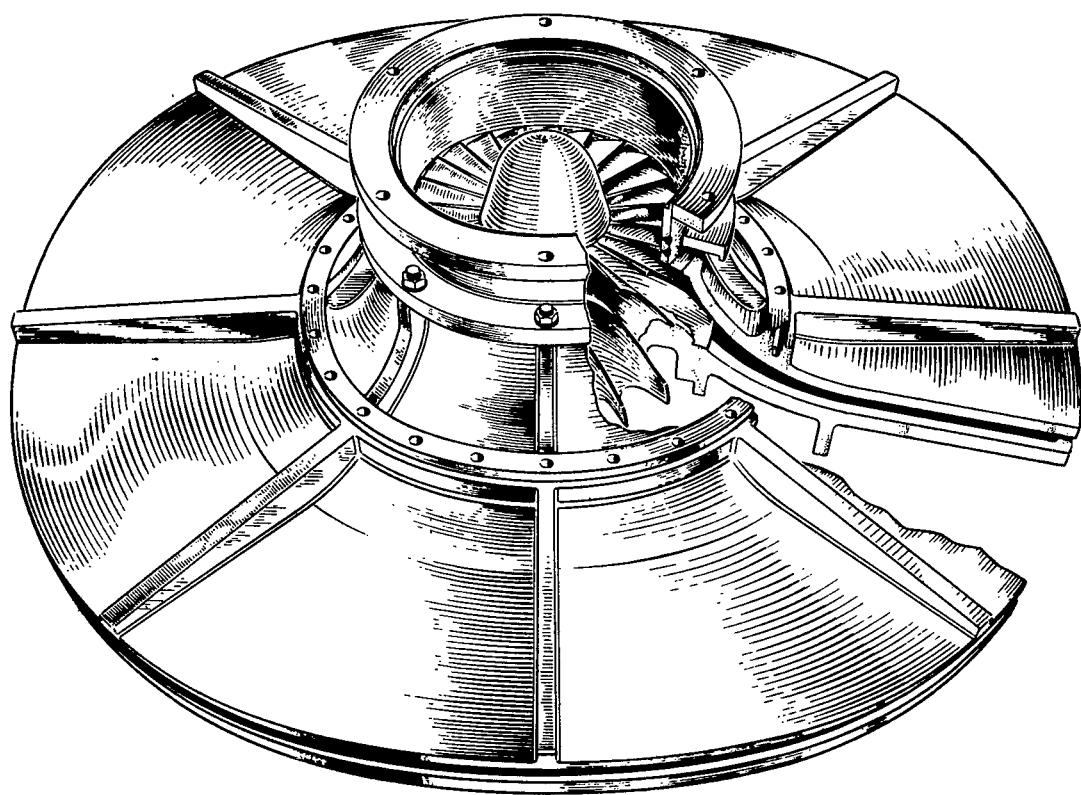
Figure 2. - Sketch of cast mixed-flow impeller with vaneless diffuser.

Diffusers. - A 34-inch vaneless diffuser, that was used with the cast mixed-flow impeller was designed to have an area expansion of a  $6^\circ$  equivalent cone along a logarithmic spiral flow path through the diffuser at design load. This diffuser design was also used with the machined impeller. The throat ratio of the vaneless diffusers (ratio of passage width at the diffuser entrance to passage width at the impeller tip) was increased from 0.534 for the diffuser used with the machined impeller to 0.748 for the diffuser used with the cast impeller. This change was made in order to obtain the best

performance from the cast impeller with a vaneless diffuser on the basis of test results from the NACA Langley Field laboratory of a similar mixed-flow impeller with diffusers of various throat ratios. Figure 2 is a drawing of the cast impeller with the vaneless diffuser.

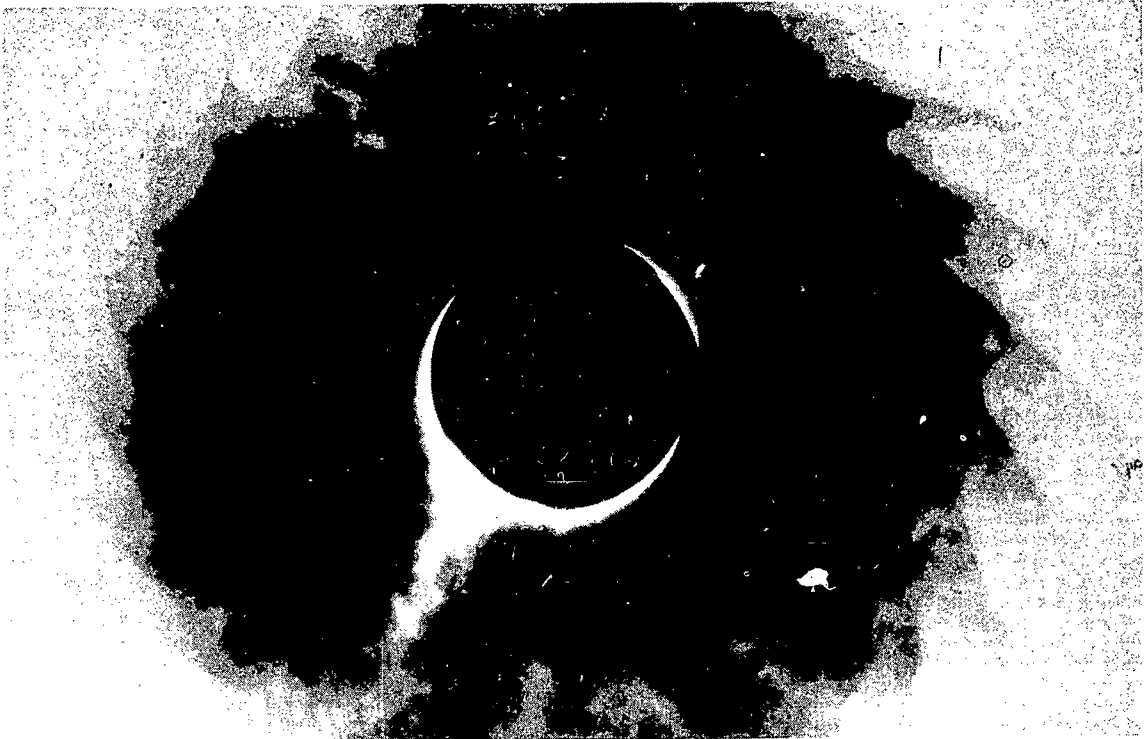
(a) Impeller 2-9, unsatisfactory impeller of alloy 2 with porosity and shrinkage cracks.

Figure 3. - X-rays of hub of cast mixed-flow impellers.

X-ray examination. - The X-ray examinations disclosed that only one of the six impellers of alloy 2 and five of the six impellers of alloy 1 could be considered satisfactory with regard to the internal quality of the castings. The X-ray photographs in figure 3 illustrate a satisfactory and an unsatisfactory hub of an impeller of each alloy. The best impeller of alloy 2 (2-23) had a slight amount of micro-shrinkage although the predominant defects of this series of castings were large shrinkage cracks and blowholes. Impeller 1-15, which had shrinkage cracks in the hub, was the only impeller of this alloy that had serious defects as shown by X-ray examination. Some of the impellers of alloy 1 had a slight amount of gas porosity, concentrated mostly in the impeller blades.

Spin tests. - Impellers 2-9, 2-22, and 2-24 had serious internal defects, as shown by X-ray examination (table I) and, consequently, broke at rather low tip speeds of 930 to 950 feet per second. Impellers 2-A and 2-6 had fewer internal defects than the forementioned impellers and broke at tip speeds near 1080 feet per second. The best

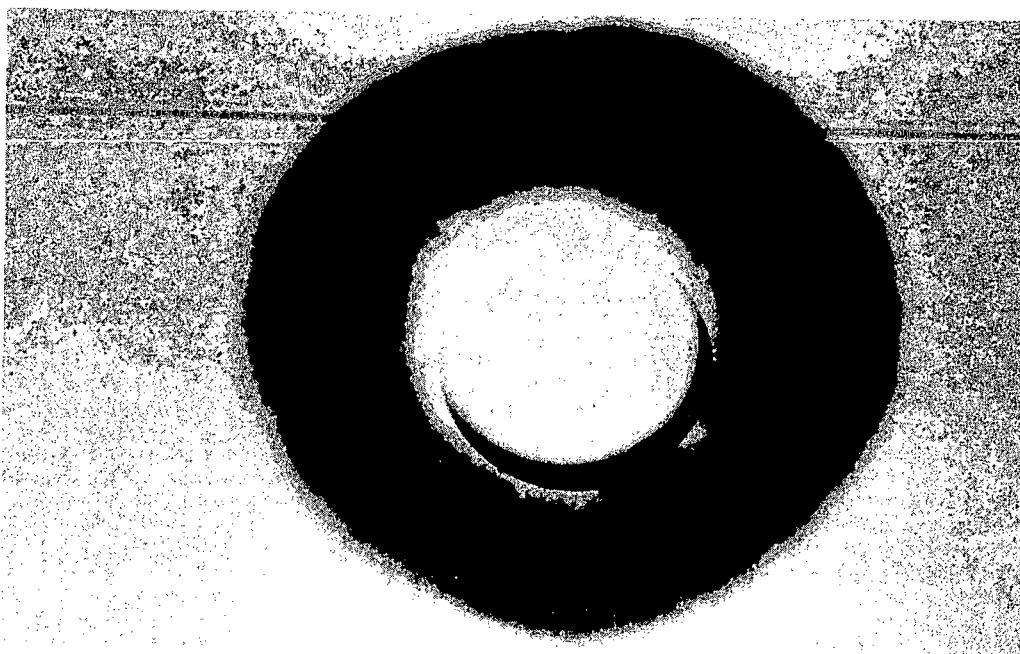
(c) Impeller 1-15, unsatisfactory impeller of alloy 1 with shrinkage cracks.

Impeller 1-15, which had shrinkage cracks in the hub as shown in figure 3(c), began to fail at a tip speed of 1475 feet per second. This impeller was not spun to destruction because radial cracks from the impeller hub were noted when the rig was shut down to measure the impeller elongation. Impeller 1-25, which had some porosity near the rear face of the impeller, and impeller 1-13, which had a fine microscopic porosity throughout, burst at tip speeds of 1641 and 1663 feet per second, respectively. Impellers 1-11 and 1-14, which were the soundest impellers of alloy 1 spin-tested, burst at tip speeds in excess of 1700 feet per second. Surface particles of impellers 1-11 and 1-14 broke loose from the impellers at tip speeds of approximately 1700 feet per second, just before bursting. The bursting speeds of the impellers are listed in table II. A comparison of tables I and II shows that the bursting speed of an impeller of any one alloy is dependent to a large extent on the nature and extent of the internal defects, which may be obtained from X-ray examination.

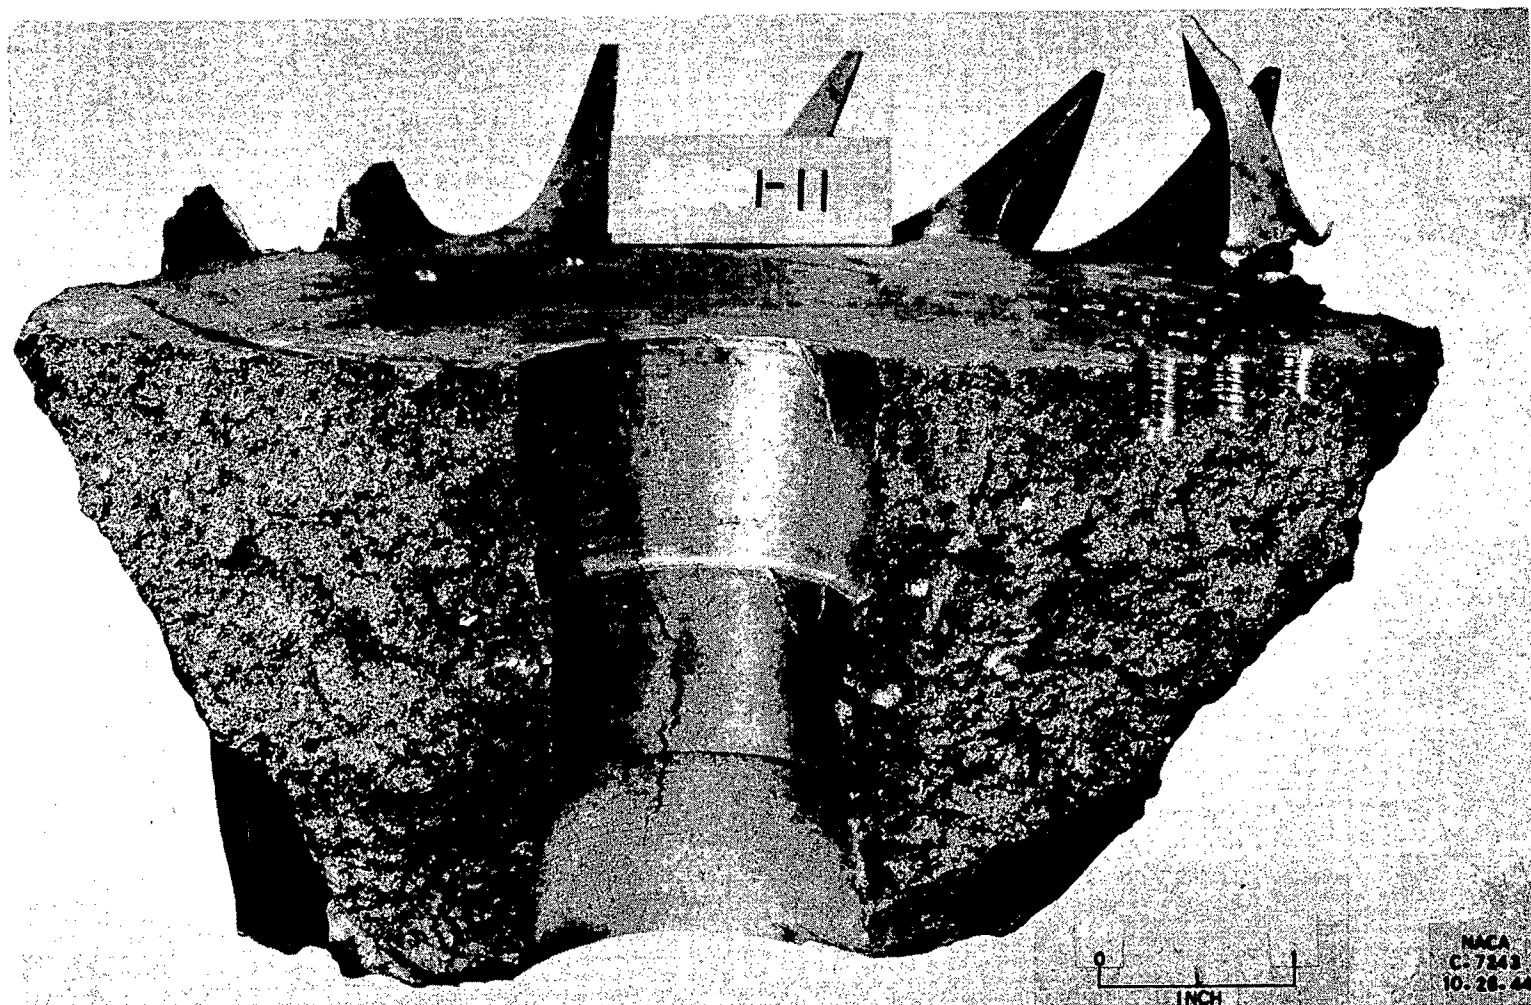
Figure 4. - Typical fragment of cast mixed-flow impeller I-11 after being spun to destruction.

All of the impellers except 1-15, which was not spun to destruction, failed through the hub. Usually the impellers burst into three parts, by splitting into halves with one of the halves further dividing into two parts. Figure 4 shows a typical fragment of cast impeller 1-11 after being spun to destruction. The roughness of the fracture indicates the porosity.

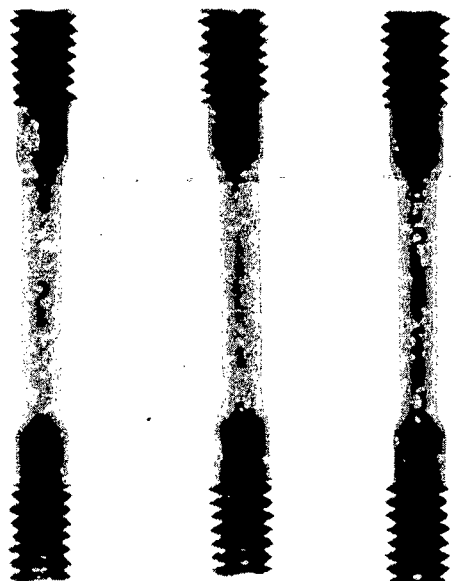
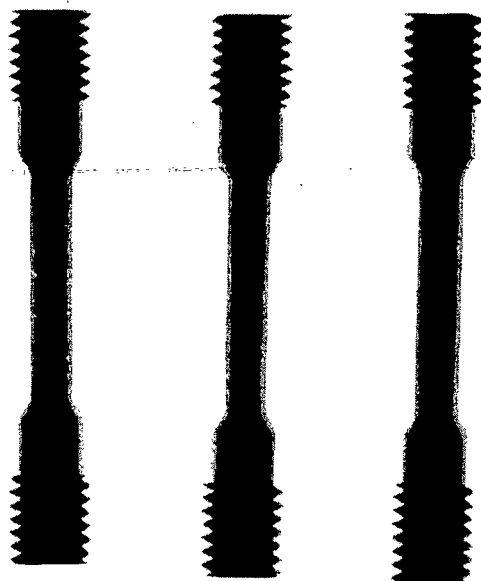
A B C  
(a) Specimens from  
impeller 2-22

A B C  
(b) Specimens from  
impeller 2-23

Figure 5. - X-ray photographs of tensile-test specimens cut from fragments of cast mixed-flow impellers.

Tensile-strength tests and X-ray examination of bar specimens. - A comparison of X-ray photographs of tensile-test specimens cut from fragments of impellers 2-22 and 2-23 (figs. 5(a) and 5(b)) with the results of the tensile tests shown in table III demonstrates that the tensile strength varies indirectly with the amount of porosity indicated by X-ray examination. The strength of the tensile-test specimens from impellers of alloy 2 varied from a maximum of approximately 110 percent to about 30 percent of the tensile strength recommended in Navy specifications. The tensile-test results of alloy 2 were erratic because of variations in the extent of porosity and other faults among the test specimens as shown in the X-ray of figures 5(a) and 5(b). The average tensile strength of all tested specimens of this alloy was 20,900 pounds per square inch.

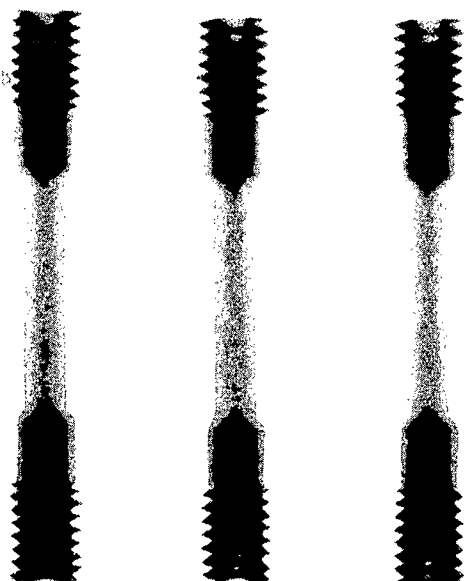
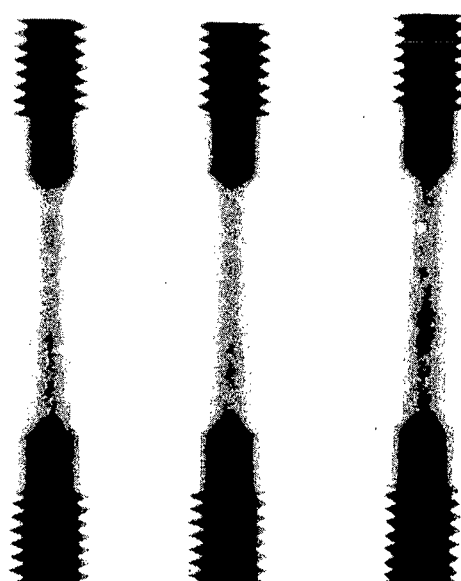
A B C  
(c) Specimens from  
impeller 1-11

A B C  
(d) Specimens from  
impeller 1-25

X-ray photographs of tensile-test specimens cut from fragments of impellers 1-11 and 1-25 are shown in figures 5(c) and 5(d). These representative X-rays show that a fine porosity exists in the specimens of alloy 1, which results in tensile strengths varying from a maximum of approximately 70 percent to 26 percent of the tensile strengths recommended in Navy specifications, except for one specimen that broke under the initial load of the testing machine. The tensile strengths of these specimens of alloy 1 are given in table III. The average tensile strength of all specimens of alloy 1 was 23,260 pounds per square inch. The results of the tensile tests of specimens taken from the impellers of both alloys indicated that the material was brittle.

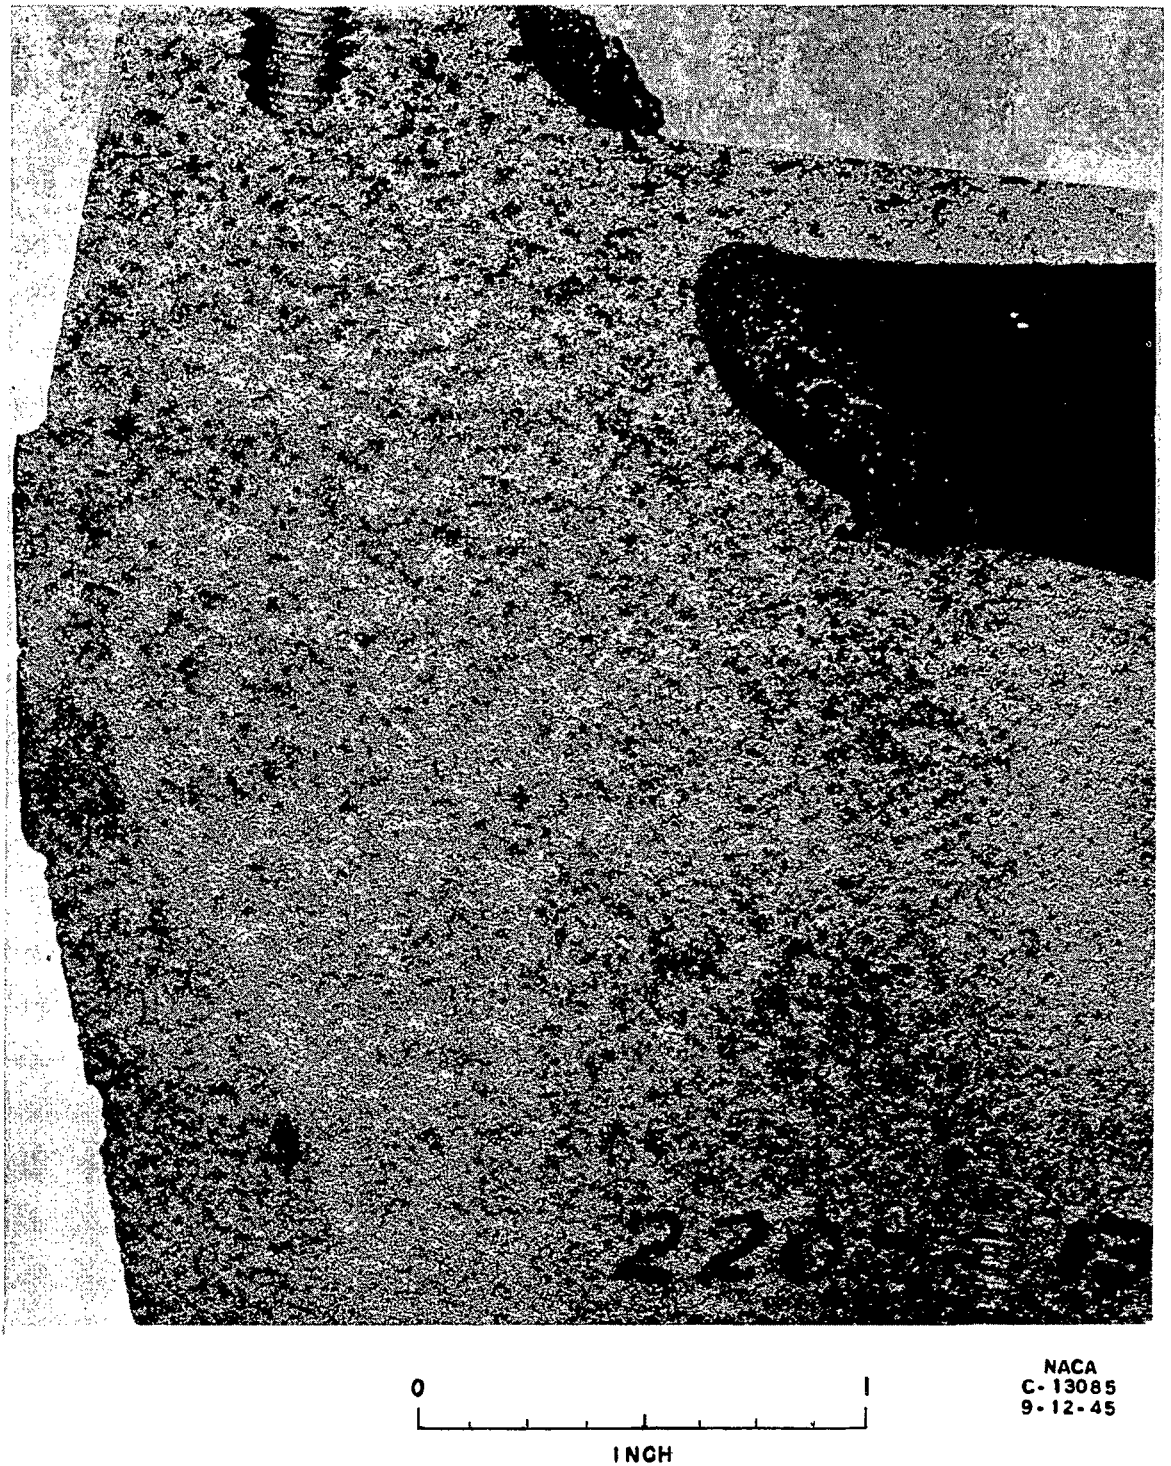
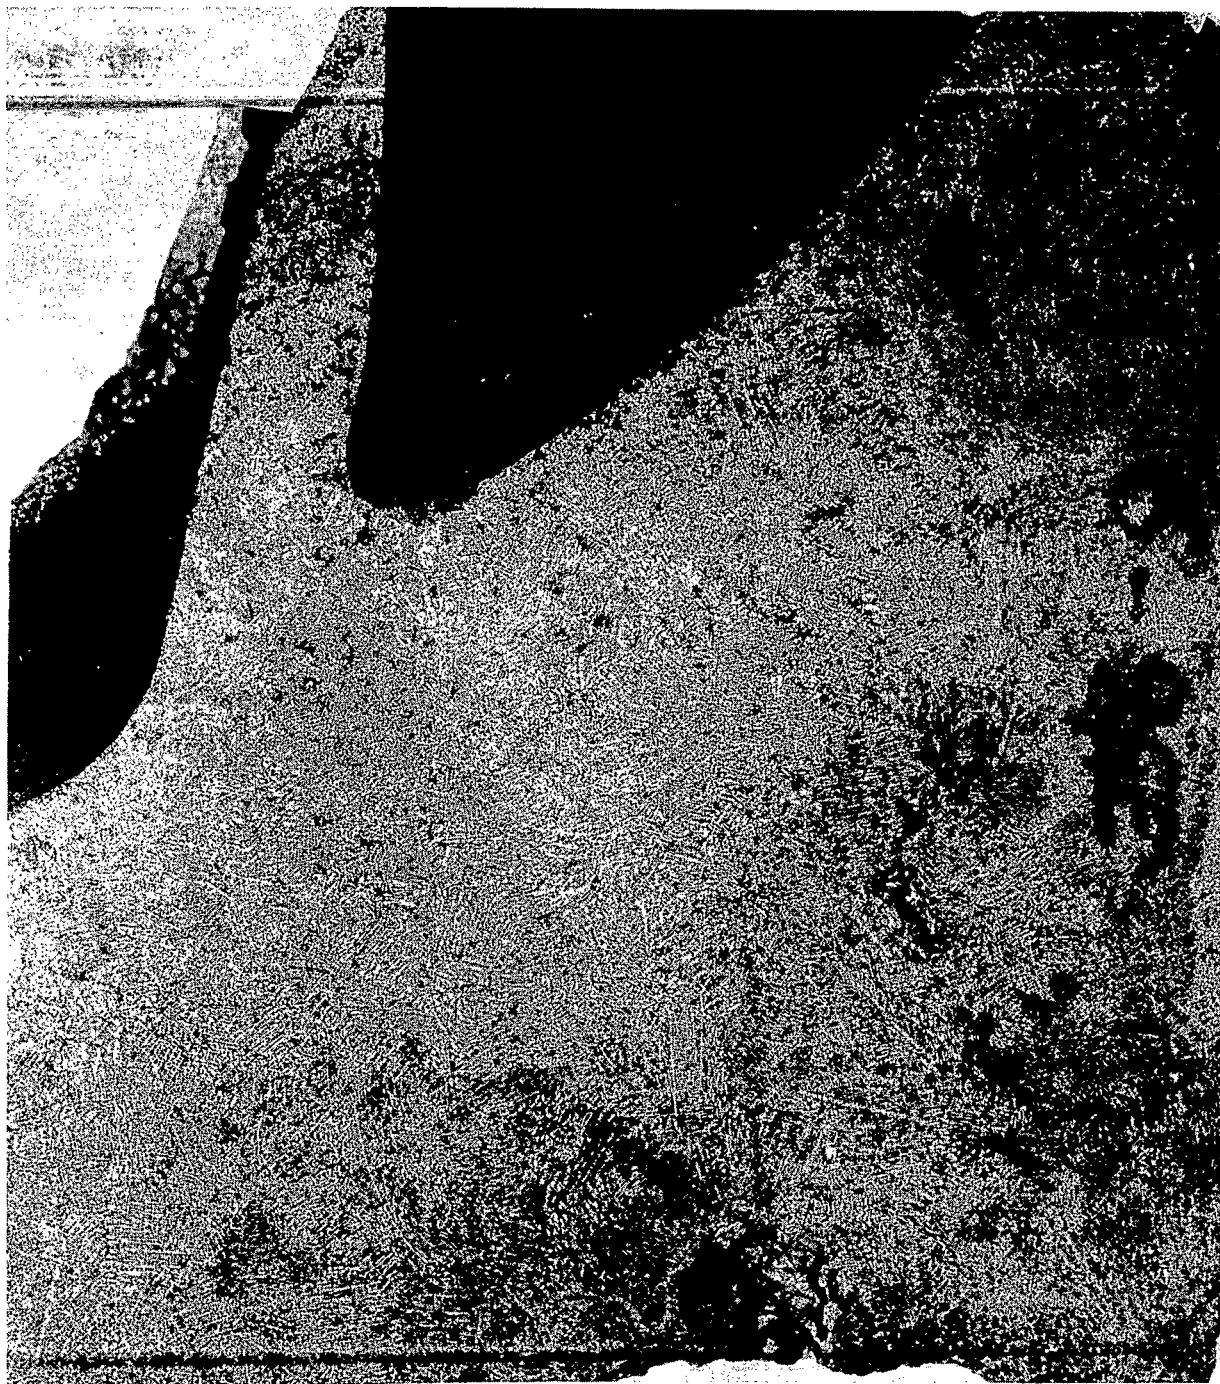
(a) Impeller 1-13.

Figure 6. - Specimens cut from the cast mixed-flow impellers macroetched to show grain structure. X2.25.

(b) Impeller 2-9.

Metallurgical examination. - Specimens similar to those used for the internal Brinell hardness determinations were macroetched to examine the grain structure of the cast impellers. The macroetched specimens from typical impellers (1-13 and 2-9) are shown in figure 6. The specimen from impeller 1-13 shows a granular grain structure, porosity, and evidence of segregation, all of which would reduce the physical strength of the impeller. (The tensile strength was less than 70 percent of Navy specifications.) The specimen from impeller 2-9 shows porosity, blowholes, and shrinkage cracks and the grain structure was somewhat dendritic.

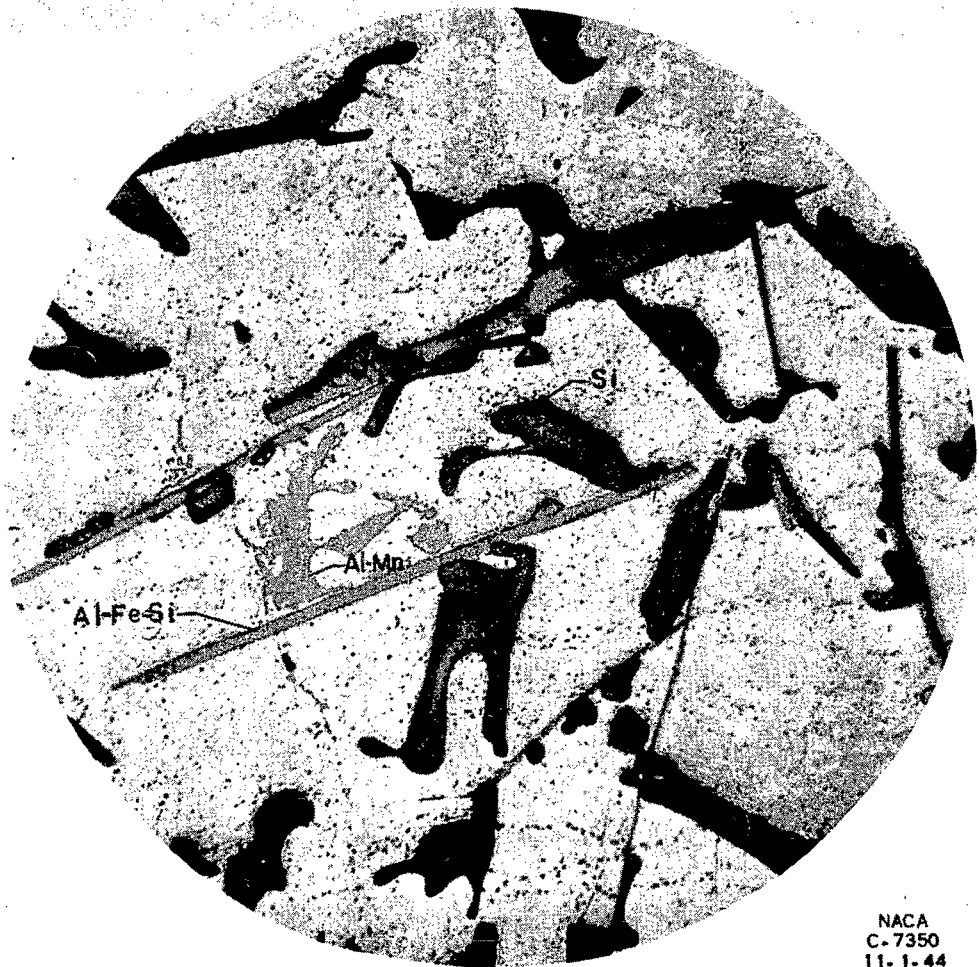
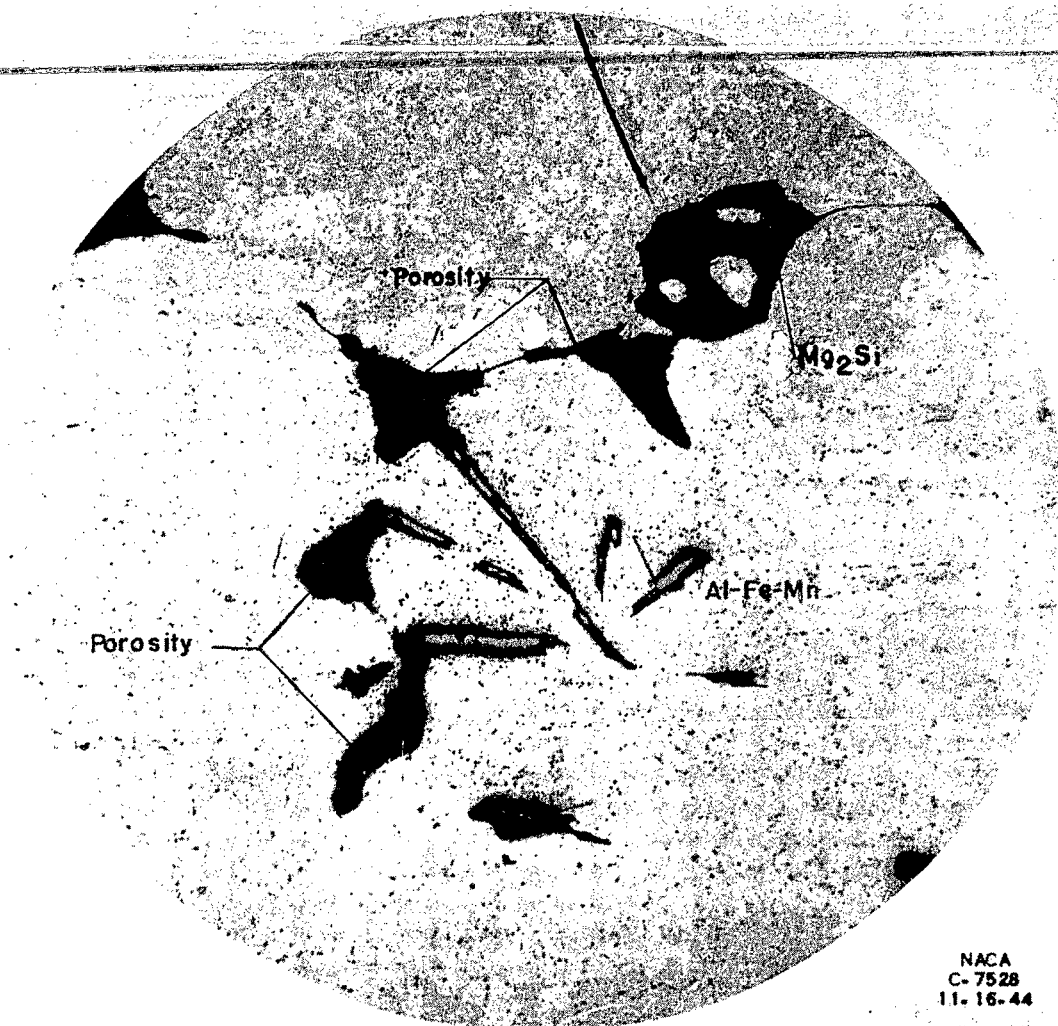
(a) From top of impeller 2-23. Etched in hydrofluoric acid.

Figure 7. - Etched specimens cut from various impellers showing porosity. X500.

(b) From top of impeller 1-II. Etched in mixed acid.  
Figure 7. - Concluded.

The structure of the alloys was further examined from photomicrographs of specimens cut from various portions of the cast impellers. A typical photomicrograph of a specimen of alloy 2 is shown in figure 7(a). The photomicrograph of the specimen showed that aluminum combined with impurities to form Al-Mn and complex compounds of Al-Fe-Si. The free silicon that came out of solution on cooling appears to be fairly uniformly distributed. The photomicrograph in figure 7(b) is of a specimen taken from the top of impeller 1-11 and shows complex compounds of Al-Fe-Mn-Co-Si and  $Mg_2Si$  and  $Al_2O_3$ . The fine porosity characteristic of this alloy is shown for impeller 1-11 at a magnification of 500 diameters in figure 7(b) and for impeller 1-15 at a magnification of 100 diameters in figure 8. The solid black areas indicate porosity. In general, the photomicrographs show that the impellers are of the normal structure with the maximum permissible amount of impurities.

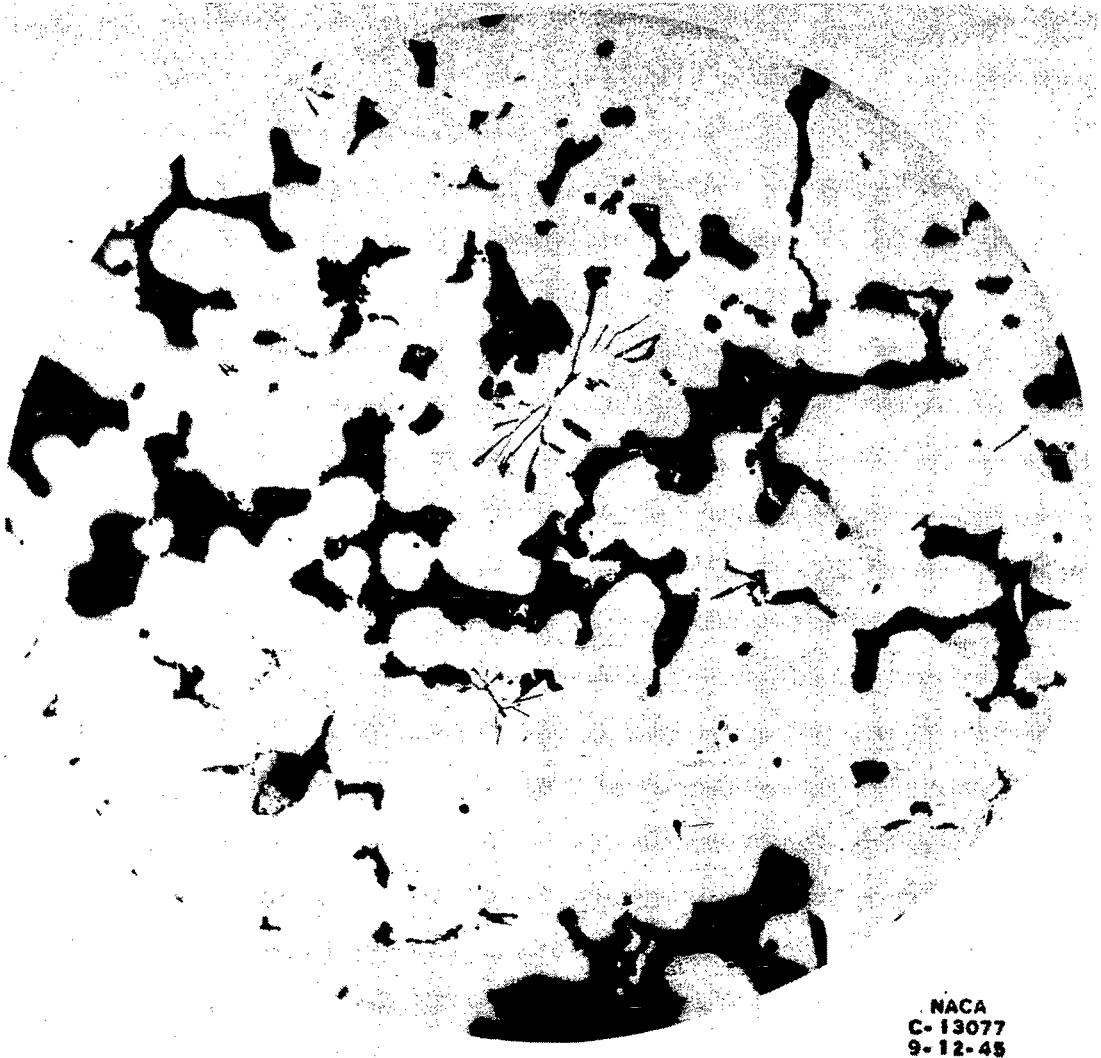
Figure 8. - Etched specimen from bottom of impeller 1-15 showing characteristic porosity of the alloy. Etched in mixed acid. X100.

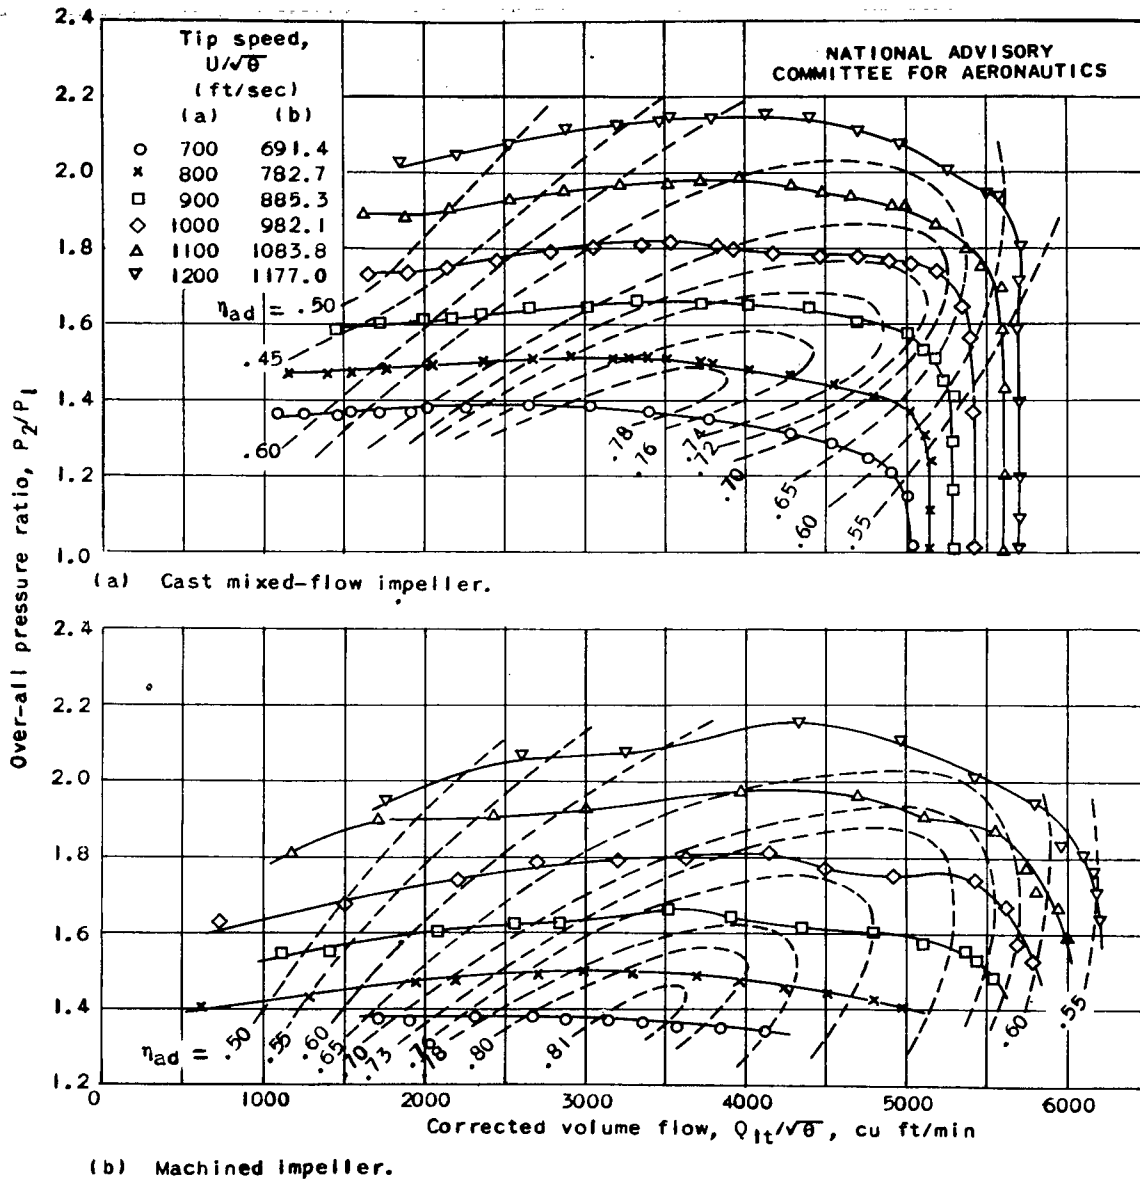
Figure 9. - Over-all pressure ratio and corrected volume flow with over-all adiabatic efficiency of impellers with NACA vaneless diffuser.

Because of difficulties in obtaining reliable data at the impeller tip caused by the highly turbulent impeller-discharge air, the cast impeller (1-12) that was not spin-tested to destruction was tested in combination with a 34-inch vaneless diffuser and the performance was determined from measurements in the test-rig outlet duct. The performance of the cast impeller is compared with that of the machined impeller in figures 9 and 10. Neither the impellers nor the diffusers were geometrically the same and the method of testing was somewhat different for the two combinations. The essential difference in the testing methods was that the Reynolds number and corrected tip speeds  $U/\sqrt{\theta}$  of the two units were slightly different. Test results show that the effect of Reynolds number is small at low Mach numbers; hence, the combined effect of the geometric and impeller surface differences can be adequately determined by performance comparison. Differences in test setup and facilities permitted operation of the cast impeller with the vaneless diffuser at a lower pressure ratio  $P_2/P_1$  than the machined impeller. This difference in minimum pressure ratios at maximum flows prevents a comparison of range at tip speeds of 700 and 800 feet per second but at all the higher tip speeds the machined impeller handled a larger corrected volume of air  $Q_{1t}/\sqrt{\theta}$  than the cast impeller (fig. 9). The difference in the maximum flows handled is probably due to the smaller passage area of the cast impeller, which causes critical air velocities (hence choking effects) through the passages of the

cast impeller at lower flows than through the machined impeller passages at comparable tip speeds. The machined impeller was also able to operate at lower flows than the cast impeller at all comparable tip speeds except 700 feet per second. For the test on the machined impeller with the diffuser at this speed, however, operation was apparently halted before final surge had been reached. The greater surface roughness and possible warping of the cast impeller probably led to early separation and consequent surge at higher flows than in the machined-impeller combination.

Although the diffuser used with the cast impeller was designed to improve the performance of this combination, results of these tests (figs. 9 and 10) showed a decrease in over-all performance compared with that of the machined-impeller combination. Most of this decrease in performance can be attributed to the differences in the impellers and is probably due to the effects of the rough casting surface and distortion of the impeller passages during casting and heat-treating.

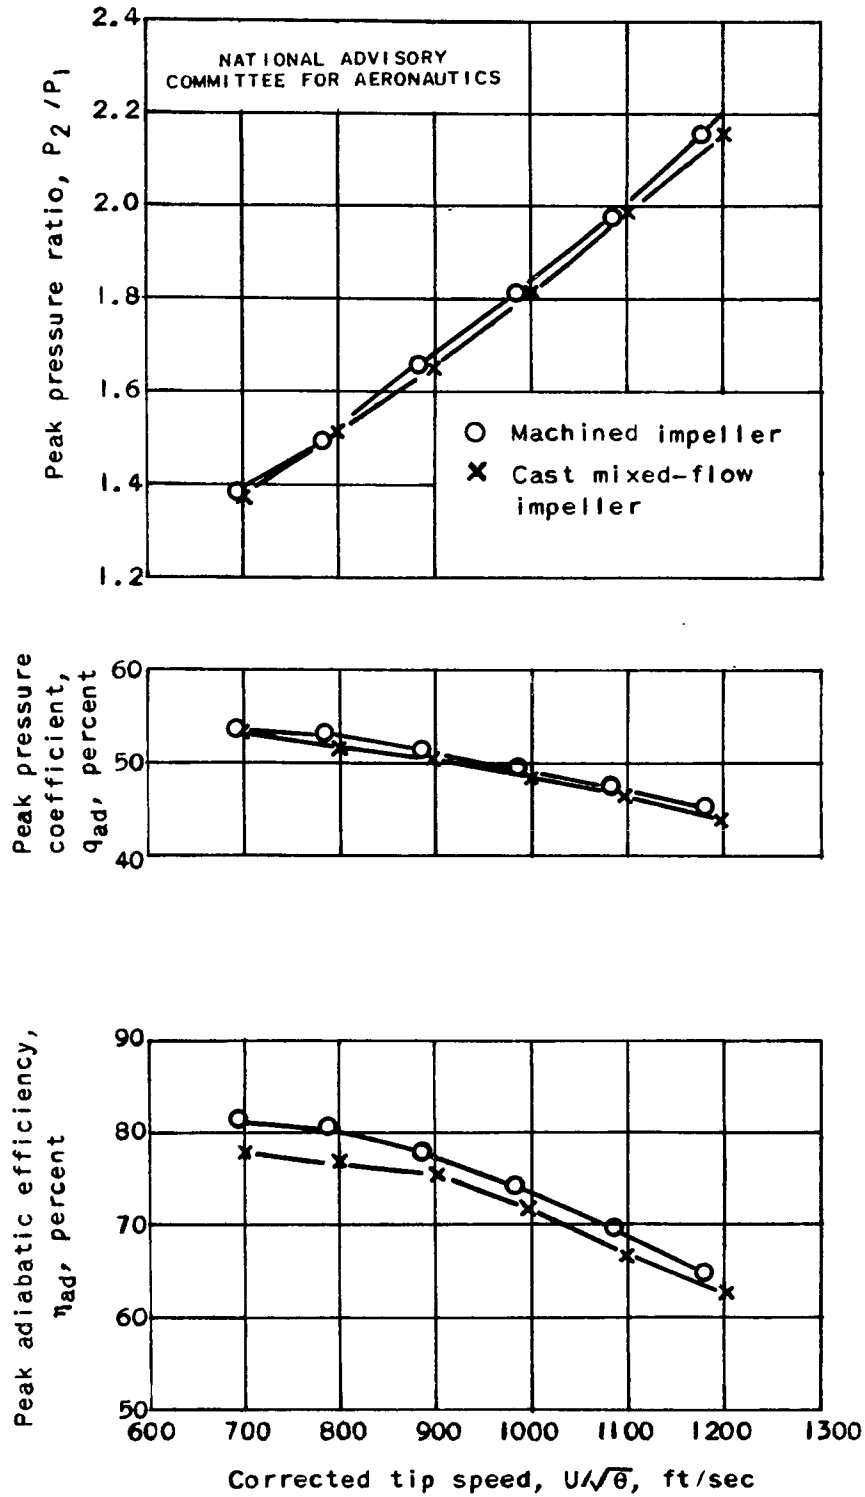
Figure 10. - Over-all peak performance of impellers with NACA vaneless diffuser.

The over-all peak adiabatic efficiency  $\eta_{ad}$ , pressure coefficient  $q_{ad}$ , and pressure ratio  $P_2/P_1$  of the two impeller-diffuser combinations are shown in figure 10. The peak adiabatic efficiency of the cast impeller with the diffuser was approximately 78 and 62 percent at corrected tip speeds of 700 and 1200 feet per second, respectively; these efficiencies were approximately 3 points lower than the corresponding peak efficiency of the machined impeller with the diffuser at low speeds and 2 points lower at high speeds. The peak pressure coefficient was approximately 63 percent for both impeller-diffuser combinations at a corrected tip speed of 700 feet per second. The peak pressure coefficient of the cast-impeller combination was slightly lower than that of the machined-impeller combination at all tip speeds above 700 feet per second; at 1200 feet per second, it was 53 percent. The peak pressure ratio of the cast impeller with the vaneless diffuser was slightly lower than that of the machined impeller with the vaneless diffuser at all corrected tip speeds. A maximum pressure ratio of 2.16 was obtained with the cast-impeller combination at a corrected tip speed of 1200 feet per second.
